TECHNICAL REPORT ARLCB TR 85008

# **WEAR OF PROJECTILE ROTATING BANDS**

ROBERT S. MONTGOMERY

**MARCH 1985**

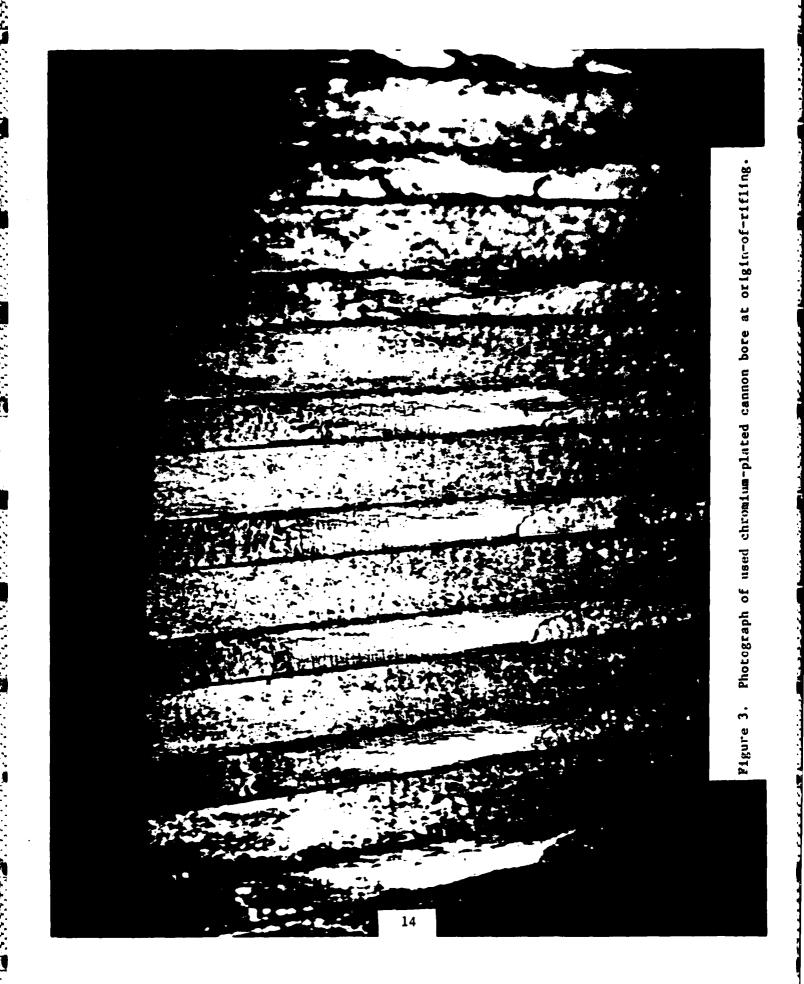
projectiles that were fired in chromium-plated tubes (ref 5). This increased wear cannot be attributed to the chemical nature of the surfaces before melt-lubrication has been established. In laboratory pin-on-disk studies with a bearing pressure of from 55,000 kN/m<sup>2</sup> (8,000 psi) to 83,000 kN/m<sup>2</sup> (12,000 psi) a gilding metal pin wore at a rate of essentially zero at a velocity of 1.70 m/s and only 0.02 mm/m at a velocity of 3.05 m/s sliding on chromium plate. Sliding on gun steel under these conditions gave wear rates of 0.07 mm/m and 0.06 mm/m, respectively. In addition, there is no reason to expect any difference at all in the melting wear in the faster sliding meltlubricated regime. There is no wear data in this regime, but there is friction data and the coefficients are identical (ref 6). It seems reasonable to attribute the increased wear with chromium-plated tubes to much greater abrasive wear near the origin of rifling. Rather large amounts of band material could well be torn off by the sharp edges produced when the plating is removed in this region. In the case of the steel tubes, there are no sharp edges and so little or no abrasive wear.

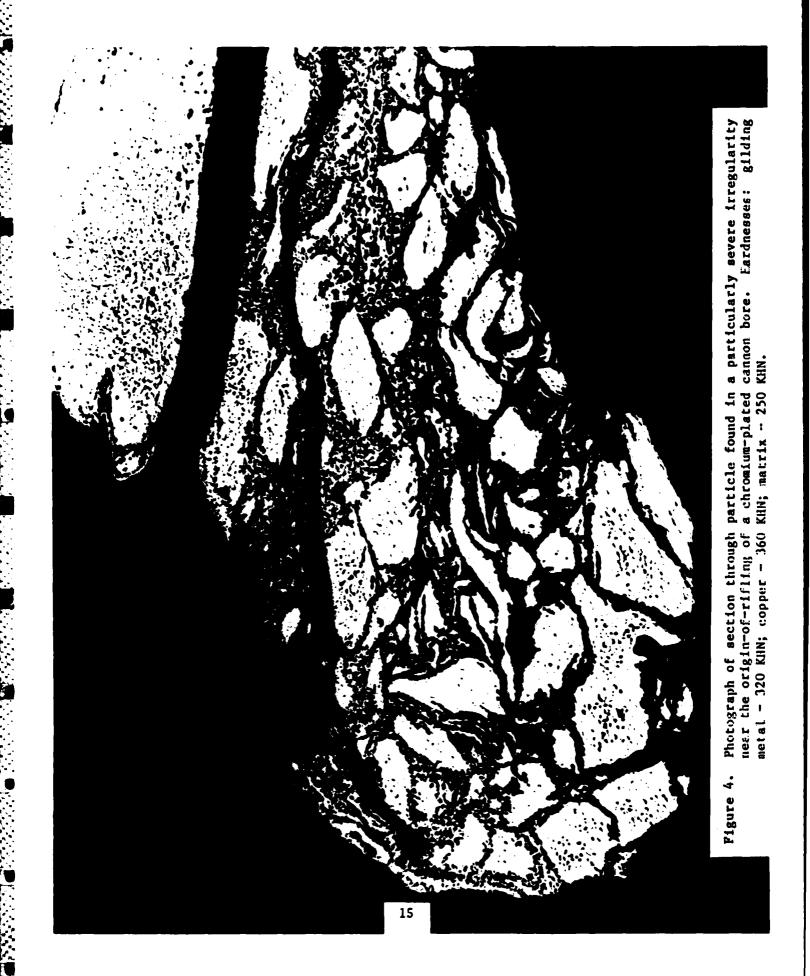
4.	Photograph of section through particle found in a particularly severe irregularity near the origin-of-rifling of a chromium-plated cannon bore. Hardnesses: gilding metal - 320 KHN; copper - 360 KHN; matrix - 250 KHN.	15

particular model of projectile which was somewhat longer than usual. This was attributed to fragments of rotating bands which had been removed from previous projectiles by irregularities in the bore topography coupled with the fact that chromium-plated bores do not wear much beyond the origin of rifling, so consequently, clearances here are closer. Even a rather small deposit can cause difficulty in chambering the next projectile in the case of a chromium-plated cannon tube. Figure 4 is a section through a particle found in a particularly severe irregularity. This particle is an agglomerate of unmelted individual particles bound together by a "mastic" of band material which had been molten.

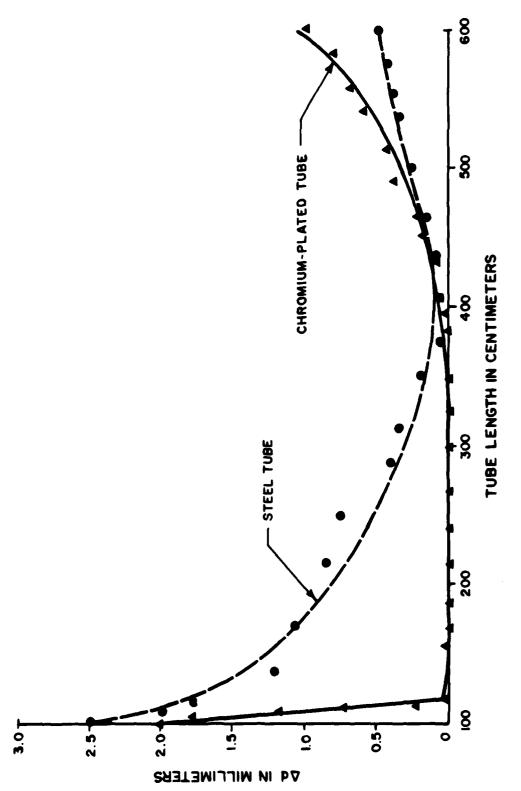
the body will contact the bore near the muzzle. While the steel of the body will form a molten surface film just as was produced on the rotating bands, for a short time there will be unlubricated sliding which will result in muzzle wear at this location and serious damage to the bore and decreased accuracy. This is illustrated by comparing the erosion of a steel bore of a developmental 155 mm cannon with the erosion of an identical chromium-plated bore (see Figure 5). There was more serious muzzle wear found with the chromium plate (ref 7).

Comparison of erosion of steel bore with chromium-plated bore after about 1800 rounds for a developmental 155 mm cannon. Figure 5.

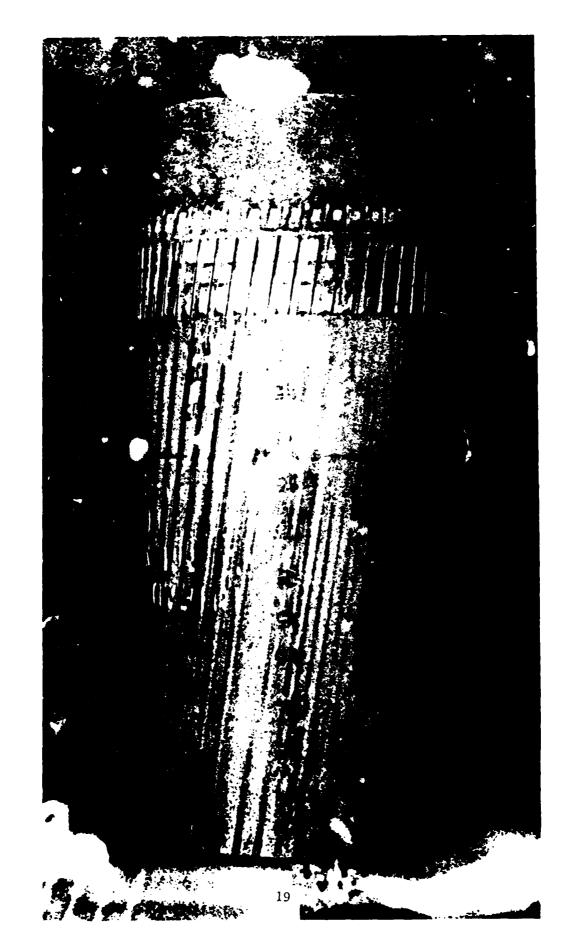
The ogive on the projectile tends to center it in the bore of the cannon and although the bourrelet remains in contact with the bore wall, it does reduce the bearing pressure on the wall. Frequently, a flat ended "slug" is used in the early stages of the development of a new cannon because these slugs are considerably less expensive than actual projectiles and actual projectiles may not be available at this time. A flat-ended slug does not have the centering of an ogive and so band wear, body engraving, and muzzle wear on the gun tube are sometimes severe. This is illustrated in Figure 8. This extreme wear then disappears when actual projectiles begin to be used.

Photograph of 155 mm slug in flight during development of new 155 mm cannon. Figure 8.
